Manhole Inspection Summary

Manhole # S11AA2005MH

Location Address: **2422 BRIARWOOD RD** Cross Street: **ROCKSPRING RD**

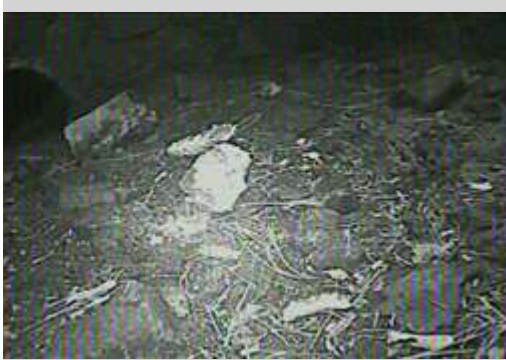
Defect

Channel Material: **Brick** ☐ Parged ☐ Debris (not Condition related)
Channel Exposure: **Fully Open** Junc Dist: **0** nearest .5 ft. Azimuth:
Condition: ☐ Sound ☐ Cracked ☐ Root Intrusion ☐ Deteriorated ☐ Leaks ☒ **Debris**

Channel debris.

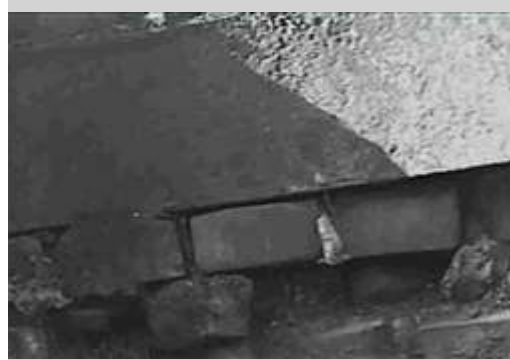
Defect

Chimney / Frame Adjustment ☒ Exists Material: **Brick** ☐ Parged Height: **6** (in.)
Condition: ☐ Sound ☐ Cracked ☐ Root Intrusion ☒ **Loose Brick** ☐ Deteriorated
Infiltration: ☐ None ☒ **Joint** ☐ Cracks ☒ **Mortar** ☐ Roots ☐ Wall

adjustment loose bricks, deterioration

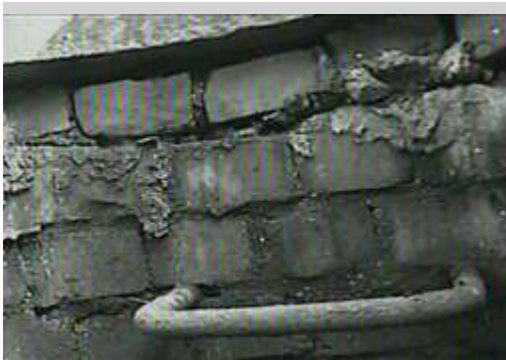
Defect

adjustment infiltration.

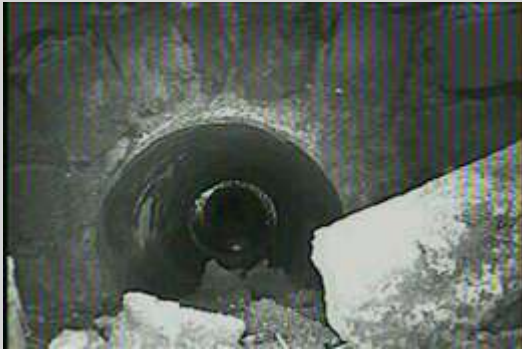
8 in. Circular Gravity Sewer
Pipe Out @ 12 O'Clock

Manhole Type: **Terminal** Location: **Roadway** Ground Conditions: **Dry**
☐ Prev. Rehab Weather: **Dry** Subject To Ponding: **None**
Comments **Cracks in pavement around manhole. O12 pipe picture indicates evidence of infiltration through the mortar of the Barrel wall.**

Deposits: ☐ None ☐ Mud ☐ Sludge ☒ **Debris** ☐ Grease

Silt Depth: **1** (in.) Deposits Extent: **Light**

Infiltration: **Evidence** Pipe Seal Cond: **Unknown**
